S-20 Dennis-Dashiell House (site) Princess Anne church parking lot c. 1867

HISTORIC AMERICAN BUILDINGS SURVEY INVENTORY

VZ/93 2. NAME Dashiell House

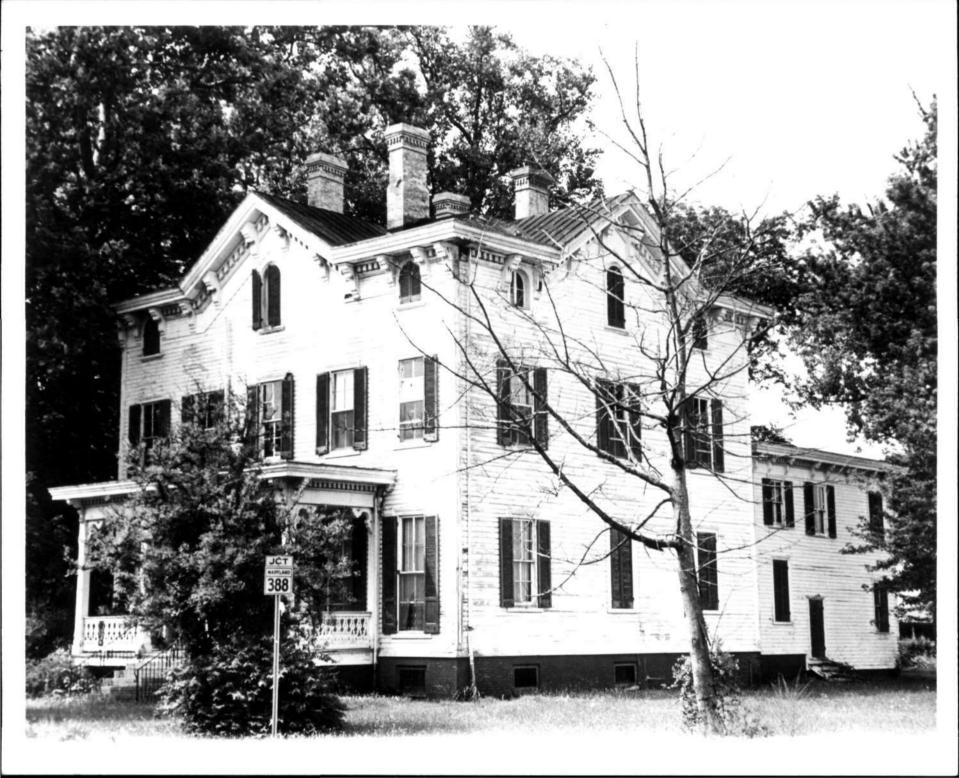
S-20
DENNIS-DASHIELL HOUSE
Princess Anne, Somerset Co., MD
Northeast elevation
1967,
Negative/MD Historical Trust

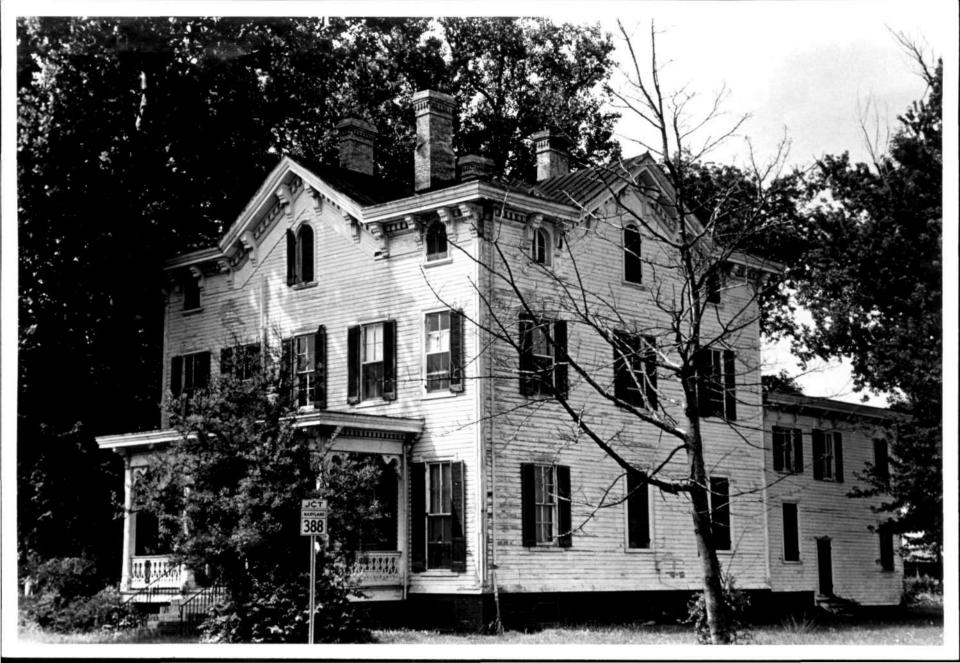
Dennis - Dashiell House Princess Anne, Somerset County Northeast Elevation Documentary Photograph - 1967 Neg/Md. Historical Trust S-20
